May 31, 2017

Feasibility Study Arlington Education Center

Arlington Public Schools

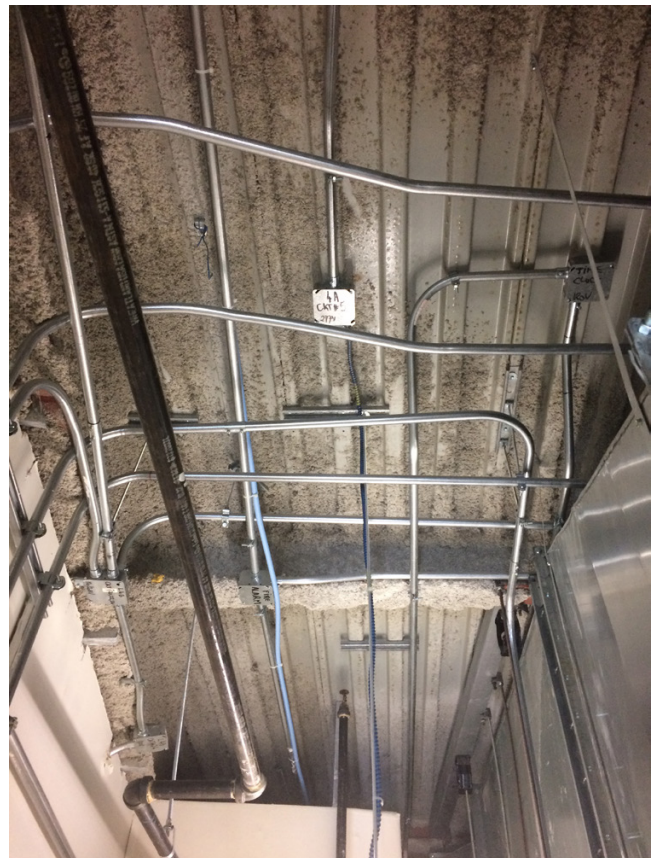
In order to meet the height restrictions of the VCC/ IBC 2012, the building must be brought up to IB construction. This will require the entire building structure be fire proofed as well as fully sprinklered-see sprinkler analysis below.

Existing steel structure, floor and roof deck will require spray applied fireproofing

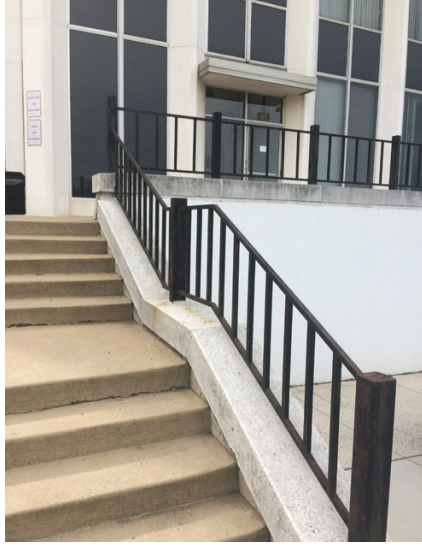
Exterior Stairs

The current handrails on the stairs in the Education Center do not meet the current VCC and ADAAG requirements. Handrails and guards must be replaced as part of the change in occupancy per VRC section 403 and section 1012.4. Note that there is an exception to the handrail extension requirement per VRC 403.1 exception 2, where handrail extensions are not required if such extensions would be hazardous due to plan configuration.

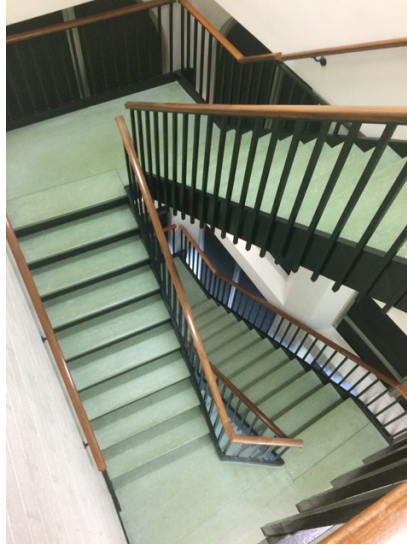
Interior Stairs

The existing stairs are signed as "areas of refuge" but do not comply with the communication or size requirements for such. Areas of refuge are not required in a fully sprinkler building. It is recommended that all "area of refuge signage" be removed.

Note that per section 1009.16, in buildings of four or more stories, at least one stairway must extend to the roof. Currently the building is not compliant with this, as the only egress to the roof is through a roof ladder in the fourth floor mechanical room.

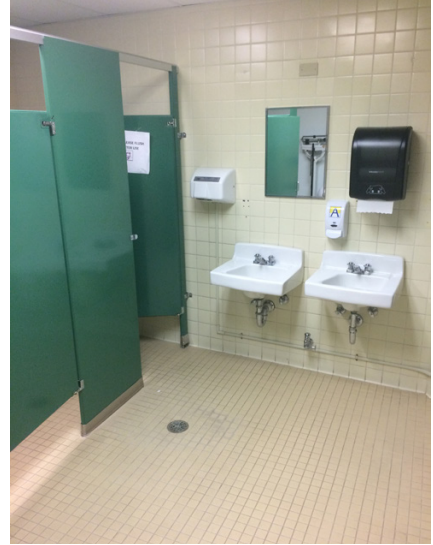
Restrooms

The current restrooms do not meet VCC/IBC or ADAAG regulations. It is recommended the rooms be reconfigured with new fixtures to comply with current regulations. The fixture count for each level will be determined based on the new occupant load for the building.

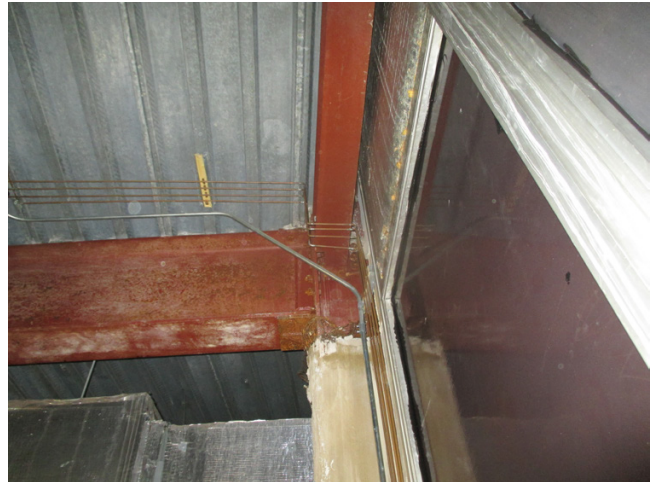
Photo #1: Typical beam-column connection detail

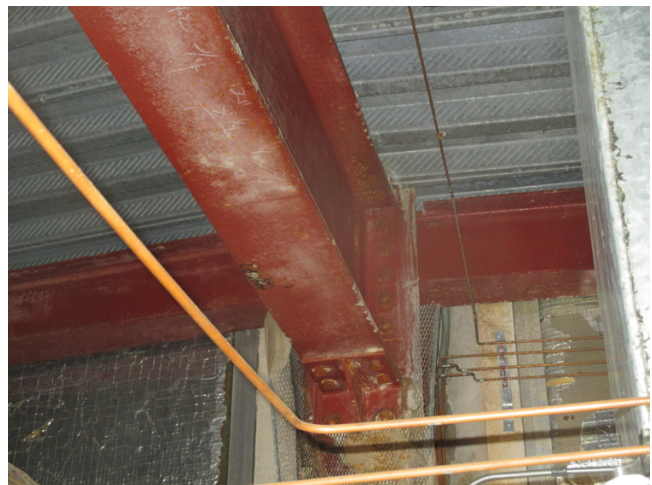
Photo #2: Typical bolted seat angle moment connection

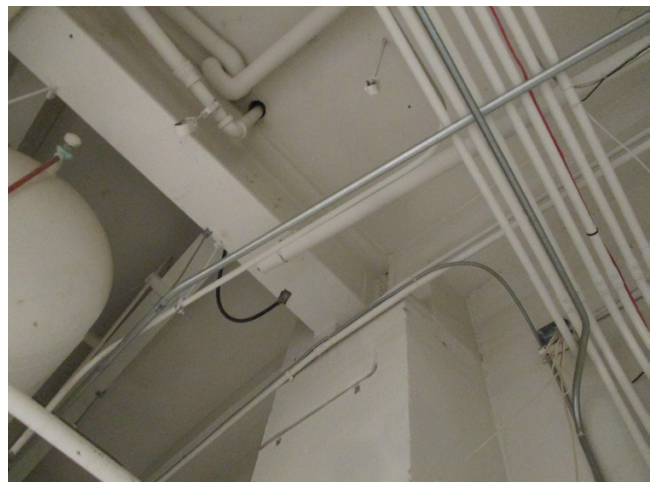
Photo #3: Steel girder to concrete pilaster connection at 1st floor

The building being radial in shape, has been framed with (3) radial column grid lines. Wide flange steel columns appear to be used at each of the grid lines running perpendicular to the radial grids. CMU walls were used at the stair wells of the building. Bolted steel moment frames were observed where the radial girders join the columns at the multiple floor levels in the building, [See Photo #2](#). This indicates that the building was likely designed with rigid steel frames for lateral force resistance. The exterior concrete foundation walls extend up to the underside of the first-floor structure. Concrete pilasters occur beneath the exterior steel column locations. [See Photo #3](#).

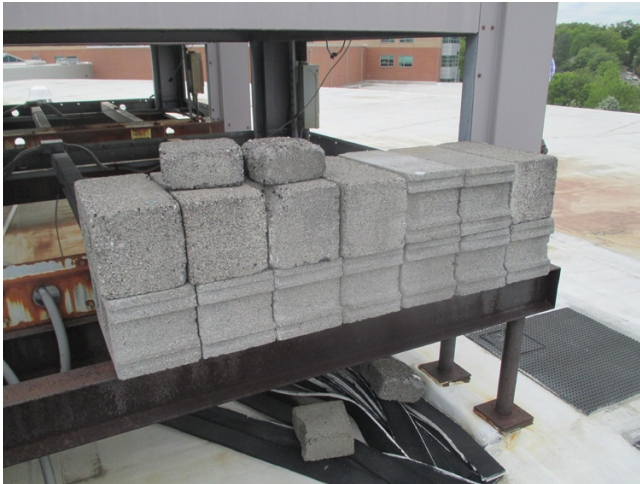
Photo #4: Stacked CMU at top of dunnage beams

The existing roof dunnage platform was also observed. The steel supporting the RTU's is lightly corroded but appears to still be in a serviceable condition. CMU blocks have been stacked on to the top of several of the dunnage beams. [See Photo #4](#). It is believed that the blocks have been added to dampen vibrations as there were no vibration isolators installed between the RTU's and the dunnage beams. Additionally, several of the existing dunnage posts are misaligned with the supporting roof curb causing the post base plates to cantilever off of the edge of the curb. [See Photo #5](#).

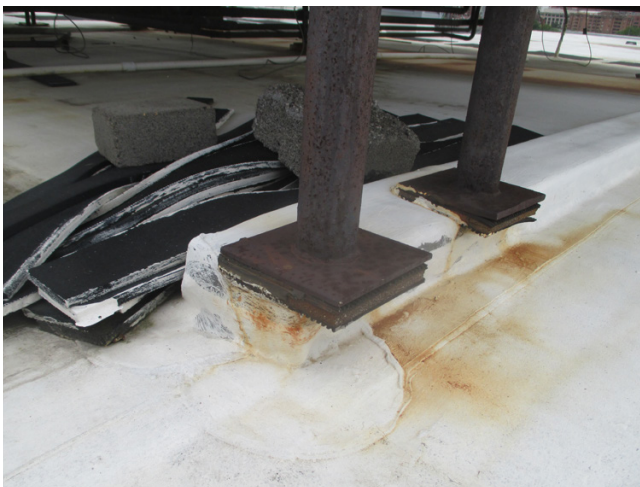
Photo #5: Cantilevered dunnage base plates

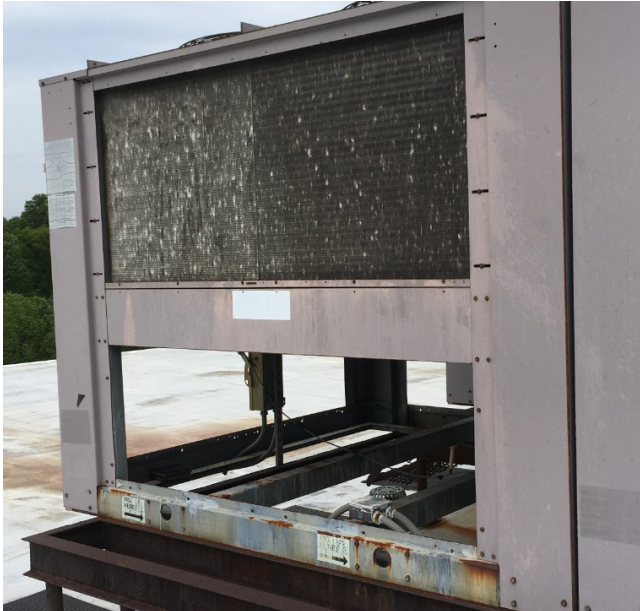
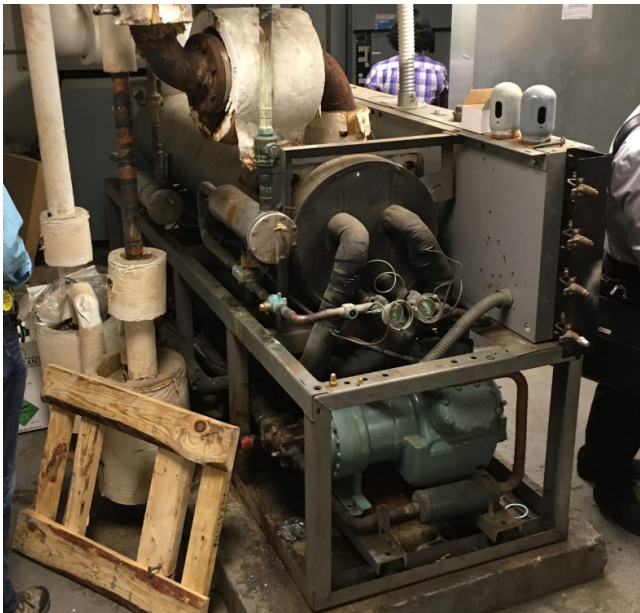
Outdoor condensing unit

Indoor chiller

We understand that the existing mechanical room on the ground floor was flooded a few days after our site visit and rendered the chillers inoperable and likely irreparable.

Based on a complete building renovation to educational use, the plant would likely have capacity to serve the new building function, however due to age, condition, and maintenance cost for an R-22 refrigerant based chiller, the chilled water central plant is recommended to be replaced in its entirety or replaced with an alternate system type (suggested VRF, see 'Air Handling Units' section below).

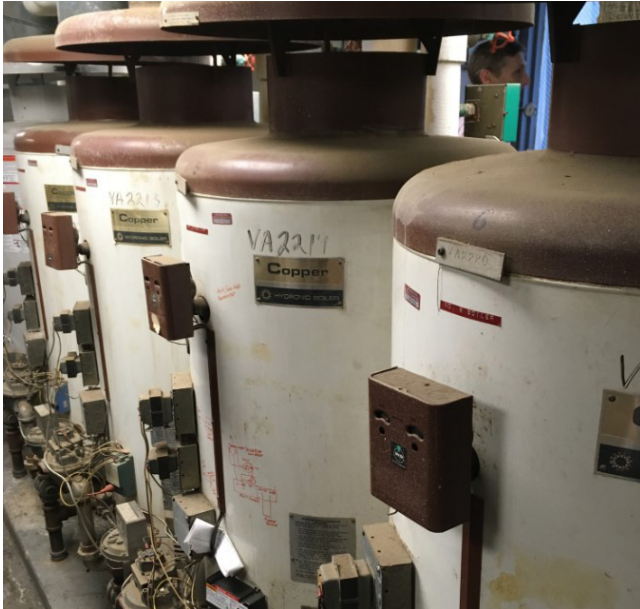
Gas fired boilers

Hydronic heating pumping is accomplished with two end suction pumps located in the ground level mechanical room. Pumping is constant volume. Pumps appeared to be in poor condition and likely beyond their useful life.

Due to the age, remaining useful life, low efficiency, and additional maintenance cost associate with such equipment, full heating hot water system and boiler replacement is likely required.

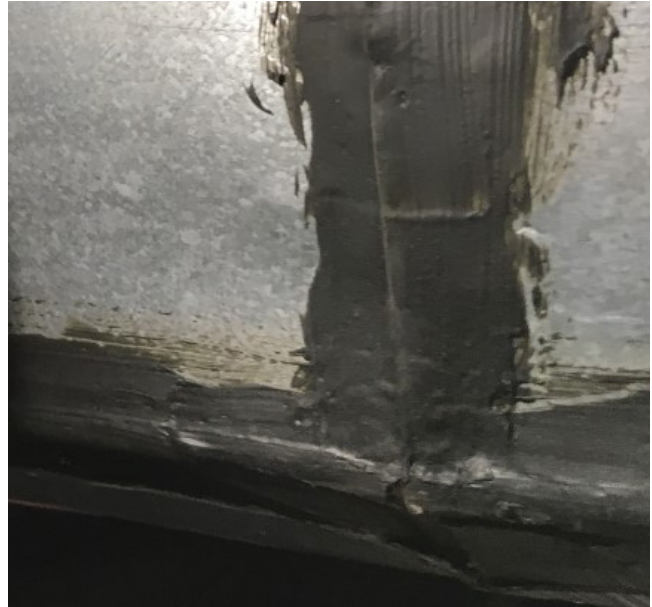
The existing duct distribution system is not adequate to serve reconfigured educational spaces and is recommended to be replaced in its entirety. In addition, existing insulation and seams appeared compromised which creates potential condensation issues as well as code compliance implications.

Ductwork

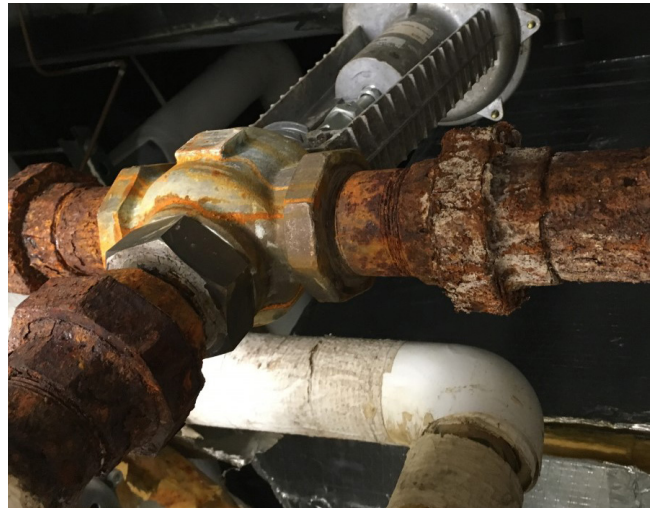
Much of the piping inspected in the central mechanical room and the secondary mechanical rooms was in poor condition. Corrosion at joints, fittings and valves was apparent. It is recommended that all hydronic piping, including accessories such as isolation valves, be replaced or completely removed if VRF is utilized for the future building use.

Hydronic piping

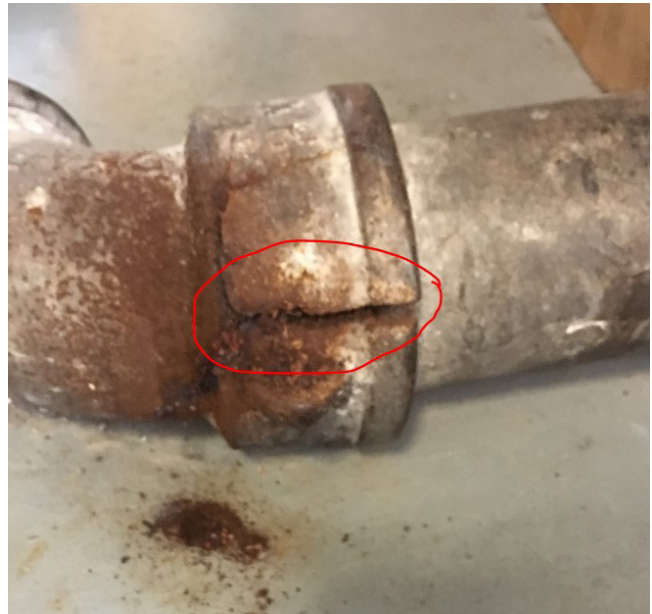
The existing storm piping appeared to be cast iron hub and spigot and vintage to the building construction. Most of the storm piping was concealed and could not be visually evaluated, however what was visible appeared to be in poor condition. A hub in the fourth floor mechanical room was cracked, presumably due to age and wear due to proximity to maintenance space. The Cast Iron Soil Pipe Institute does not publish a life span for cast iron pipe, rather recommends pipe wall thickness evaluation to determine feasibility for reuse. In Stantec's experience, average life in a commercial building of this age and type is approximately 50-60 years. It is recommended that storm pipe within the building be further evaluated for future use. It is likely that a total replacement will be required.

Storm piping

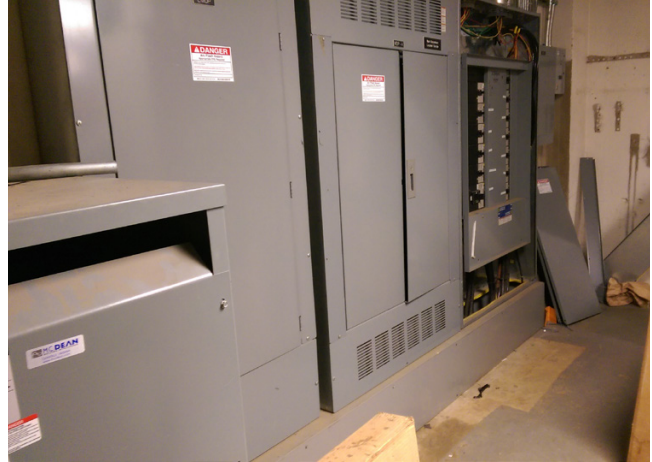
Existing electrical main switchgear in mechanical room

The existing electrical service provides approximately 665kVA of power or 12.5W/SF based on 53,000 total square feet. Educational facilities are typically provided with at least 20W/SF to allow for enough capacity for cooling, heating, lighting, warming/catering kitchen (non-commercial), and miscellaneous loads. If a full commercial kitchen will be provided, it may adversely affect the total size of the service. Based on this power allowance, it is suggested that the electrical service as well as the existing switchgear be replaced to accommodate 1200A, 480/277V. A study must be performed on Switchboard #1 in Washington-Lee High School to determine if it can accommodate the upgraded electrical service to the Education Center. The study should be based on the actual peak demand determined by the electrical utility bills over the past 12 months or longer if the data is available. If Switchboard #1 can accommodate the upgraded service, additional conduits may be required between the buildings. If Switchboard #1 cannot accommodate the upgraded service, then a new pad mounted utility transformer and

In addition, it is suggested that the new switchgear be relocated from the present location. The existing switchgear is located in the main mechanical room with numerous pipes, ducts, expansion tanks, etc. over and around the switchgear without any protection as required per NEC 110.26. According to information received from the on-call engineers, the facility experienced a flood in this mechanical room when a cold water pipe serving the domestic water heater burst sometime during the night / morning of May 7, 2017. The flood caused damage to the existing chillers and space heating boilers but was contained only to the mechanical room. The electrical equipment was not damaged and is presently fully functional. Notwithstanding this, it is suggested that the switchgear be opened and properly assessed by a licensed forensic electrical investigator to determine if there is further damage. It is highly suggested that the new electrical switchgear be placed on a 6" housekeeping pad located in a main electrical room to separate it from mechanical equipment to properly protect the equipment and also provide the NEC required clearances around it.

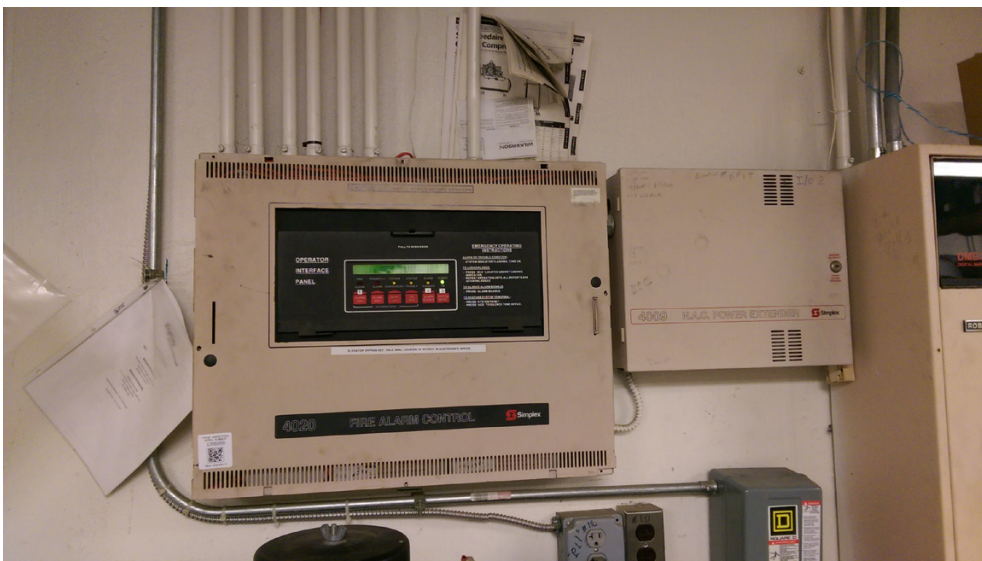
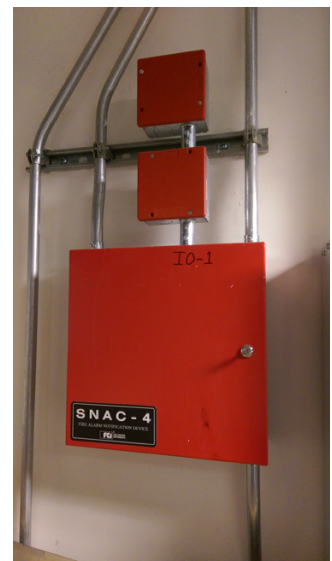
The existing fire alarm system is manufactured by a Simplex 4020 fire alarm control panel (FACP) and is obsolete. The entire existing fire alarm system including the FACP, NAC panels, power extender panels, local audible and visual devices, etc. will be replaced since it is not compatible with current addressable devices and equipment.

Existing fire alarm control panel and equipment

Typical fire alarm NAC panel
