## ASSESSMENT

### LUBBER RUN RECREATION CENTER

300 North Park Drive  
Arlington, Virginia 22209

**EMG Project #:** 88516.08R-048.017  
**Date of Report:** December 15, 2008  
**On site Date:** July 31, 2008

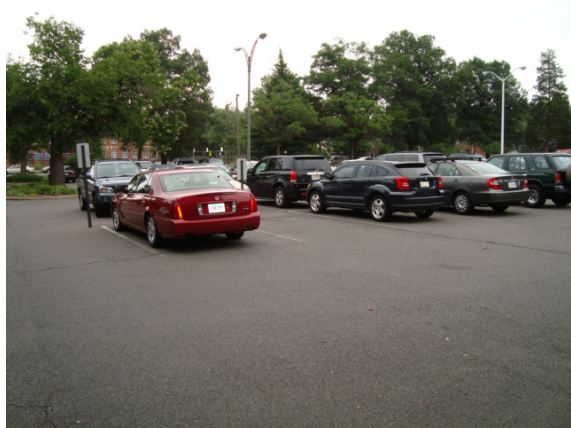
Photo #10:	Parking lot
------------	-------------

- The pavement is in fair to poor condition with cracking and potholes. In order to maximize the pavement life pothole patching and a pavement mill and overlay will be required during the evaluation period (20 years). The estimated cost of this work is included in the Deficiency Cost Table.
- The concrete sidewalks will require repair and replacement during the evaluation period. They have cracked sections with several displaced areas of concrete. The estimated cost of this work is included in the Deficiency Cost Table.
- The concrete curbs, and steps throughout the property are in good condition. Routine cleaning and maintenance will be required during the evaluation period.

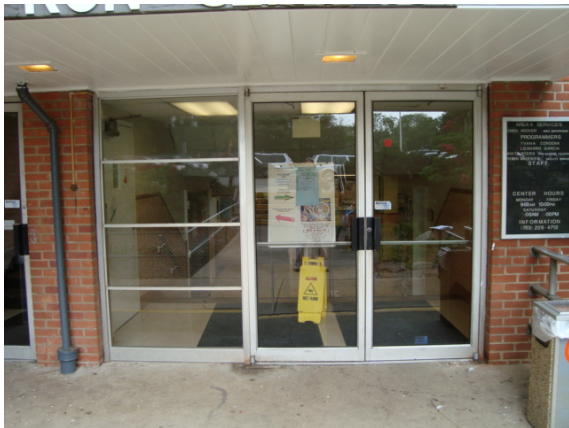
Photo #11:	Entrance doors
------------	----------------

- The storefront entrance doors are in good condition. Based on the estimated Remaining Useful Life (RUL), the doors will require replacement during the evaluation period. The estimated cost of this work is included in the Deficiency Cost Table.
- The exterior doors and door hardware are in good condition and will require routine maintenance during the evaluation period.

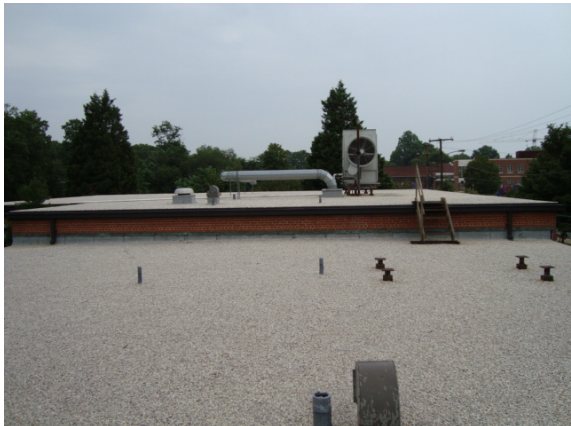
Photo #15: Roof

- The roof was replaced in 2005 and is in good condition. Information regarding roof warranties or bonds is not available. The roof is maintained by an outside contractor. Based on its Remaining Useful Life (RUL), the roof will require replacement near the end of the assessment period. The estimated cost of this work is included in the Deficiency Cost Table.
- According to the POC, there are no active roof leaks. There is no evidence of active roof leaks.
- There is no evidence of roof deck or insulation deterioration. The roof substrate and insulation should be inspected during any future roof repair or replacement work.

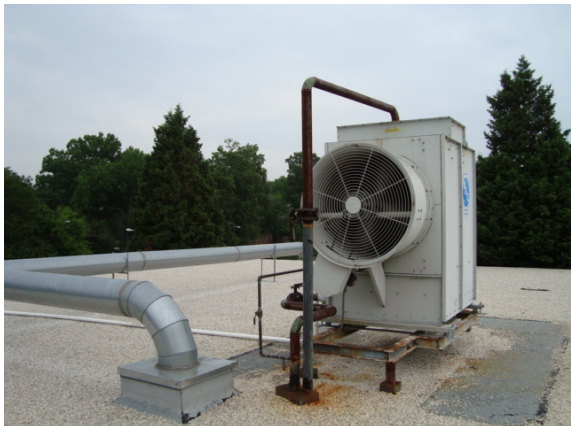
Photo #17: Cooling tower

- The cooling tower is relatively new and in good condition. Based on its estimated Remaining Useful Life (RUL), the cooling tower will require replacement during the evaluation period. The estimated cost of this work is included in the Deficiency Cost Table.

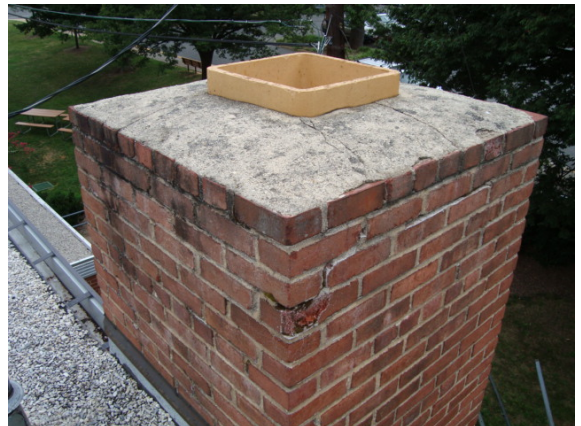
Photo #18: Chimney - note deteriorated masonry

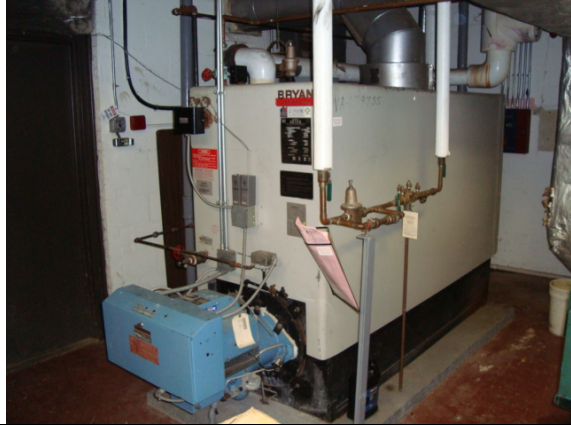
Photo #20: Boiler

- The boiler appears to be in good condition. Based on the estimated Remaining Useful Life (RUL), the boiler will require replacement during the evaluation period. The estimated cost of this work is included in the Deficiency Cost Table.

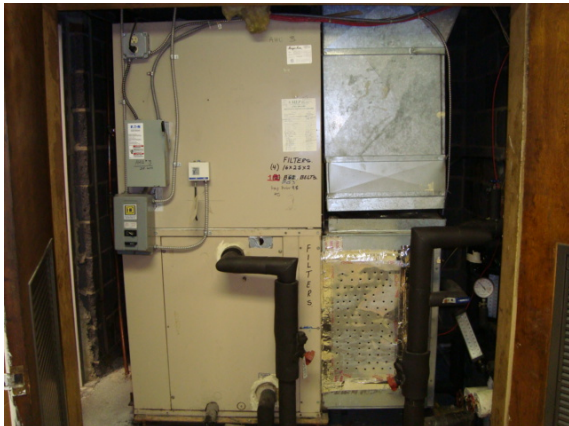
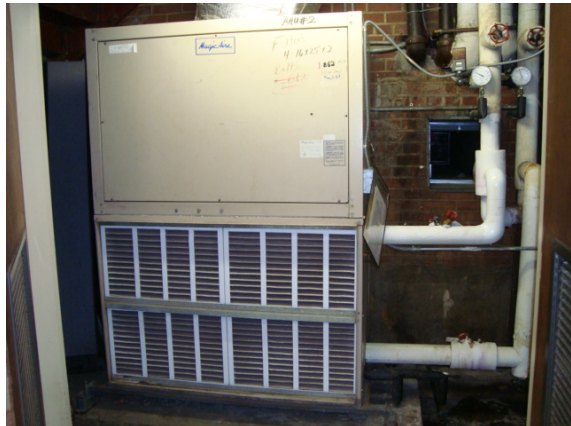
- The HVAC equipment varies in age. Based on their estimated Remaining Useful Life (RUL), the associated air handlers and compressor will require replacement during the evaluation period. The estimated cost of this work is included in the Deficiency Cost Table.
