*Arlington Career Center
Feasibility Study*

THE EXISTING FACILITY

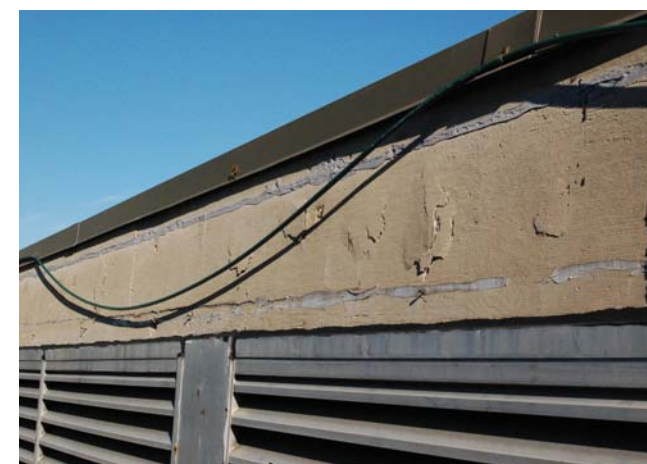
Photograph P1

Overall, the building is structurally in fair condition. The structure of the building is performing adequately, though perhaps, not as well as was intended by design. At the exterior of the building, the issues noted consist of minor concrete deterioration at sporadic locations around the building perimeter (Photographs P1 through P8). Items of note are:

- cracks in the concrete wall
- concrete spalls with exposed and corroded reinforcing bars
- erosion of concrete surfaces

Exterior Concrete Repairs (Photographs P1 through P9) :

Remove loose, delaminated, and spalled concrete from sporadic locations around the perimeter of the building by chipping. Wire brush or machine clean exposed and corroded reinforcing steel, and paint exposed reinforcing steel with zinc rich primer.

Patch prepared repair areas with two-part, polymer-modified cementitious patching mortar. We estimate 40 instances of 5 square feet, uniformly distributed around the exterior of the building, for a total of 200 square feet.

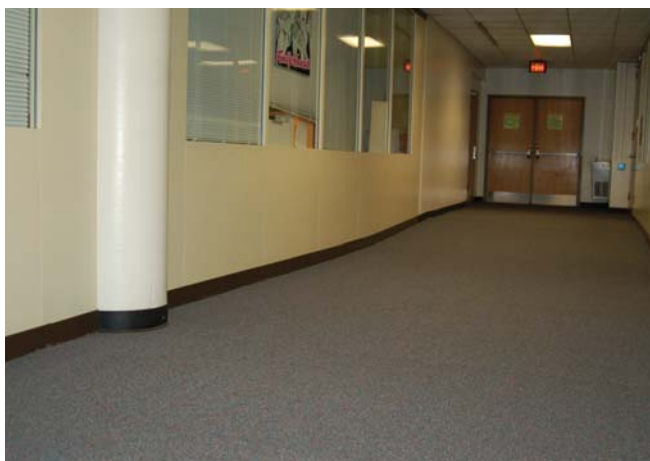
Photograph P10

At the interior of the building, one significant issue was observed to occur at two specific locations. Significant deflection of the elevated floor slabs was observed at each side of the column lines along the two expansion joints (Photograph P10 and P11). Based on our discussion with some of the staff in the building at the time of the survey, this condition has been evident for a long time.

This observation prompted us to perform some very preliminary calculations for the elevated floor in these framing bays, in order to provide a basic understanding of the conditions. Based on these preliminary calculations, we believe that portions of the elevated floors are likely to have live load capacities less than the 100 PSF indicated in the drawings.

In our opinion, the excessive deflection appears to be a combination of elastic deflection due to the slab thickness given the pinned condition; and plastic deformation, or creep, due to under-reinforcement of the slab. This condition will require a more in-depth study by a qualified structural engineer, in order to determine actual live load capacity, and to establish if the available load capacity is sufficient to satisfy code required minimums.

If as a result of this in-depth study, it is determined that strengthening of the structure in the four bays affected by this condition, it is likely that the slab would have to be strengthened by the addition of steel beams and columns underneath the slab. Additional columns would be added to shorten the slab spans and beams would be added to stiffen and strengthen the existing slab. The upper surface could then be made level with a self-leveling cementitious topping material.

If found to be deficient, add a single line steel columns and beams at mid-span of each of the four bays (each side of the expansion joints). Columns will extend two-stories to the underside of the roof and will bear on new concrete spread footings constructed beneath the grade slab.

Portions of the grade slab must be removed and replaced in order to install these footings. We estimate W12 steel columns on the column on the same spacing as the 18" concrete columns, heavy W18 steel beams, and 8 foot square by 20 inch thick concrete footings.

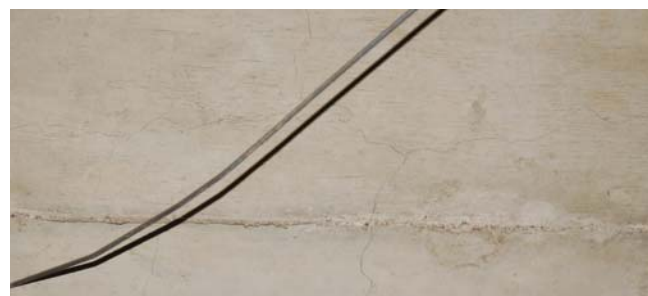
Photograph P12

Review of the underside of the 10 inch, two-way, slab reveals the presence of hairline pattern cracking (Photograph P12). The cracks are present in the mid-span of the building bays each side of the expansion joints and tend to run predominately in a direction parallel to the adjacent expansion joint.

Review of the structural drawings reveals that the reinforcing bar sizes, spacing, and distribution for the typical building bays is the same as used in the bays adjacent to the expansion joints. The amount of bottom reinforcing steel, mid-span, on each side of the joint does not increase, as would be structurally expected adjacent to an expansion joint, or “pinned” condition. Similarly, the plans show the reinforcing as if it were continuous over the expansion joint, but the expansion joint details clearly indicates that reinforcing is interrupted by the joints.

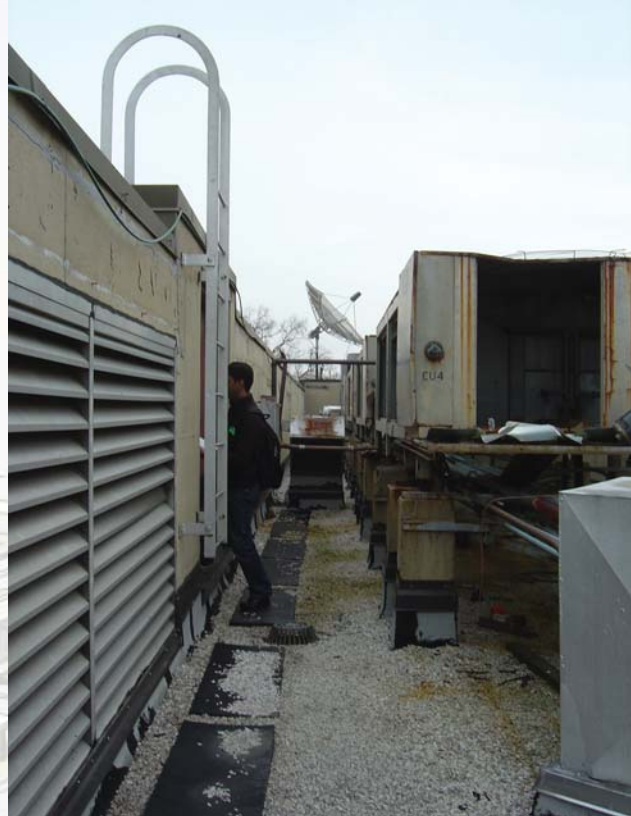
Roof Top Mechanical Equipment

access doors have visible air gaps when closed. The roof mounted condensing units are in poor condition. The existing cooling system appears to be in poor condition, well beyond its intended service life, not energy efficient, and incapable of providing appropriate levels of zone temperature control to meet present educational requirements. The outside air levels are also well below the levels expected to meet present building codes.

A completely new heating, ventilation, and air-conditioning with appropriate building and zone control is required. The new system will provide appropriate ventilation and filtration for the health of the building occupants, and appropriate energy conservation features for the benefit of the County in accordance with current energy code standards. In general, the system has exceeded its expected useful life and will need more and more maintenance. Despite ongoing maintenance, it will continue to perform below expected minimum standards.

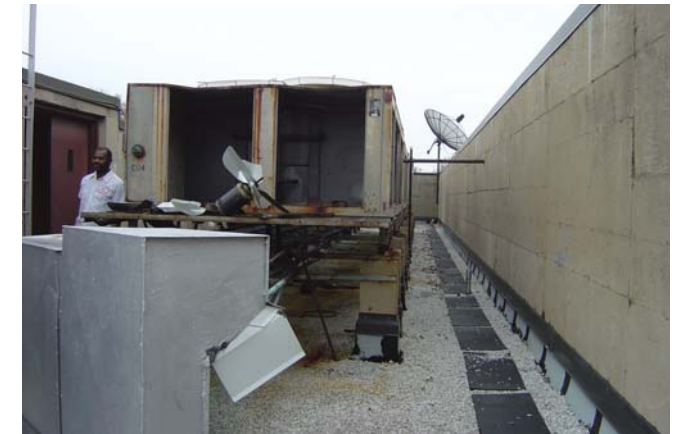
Roof Top Mechanical Equipment

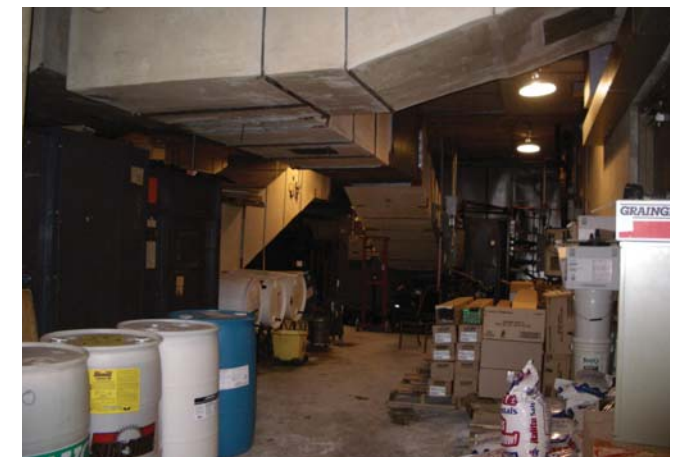
It appears that the majority of the air-conditioning system is original equipment installed when the building was first constructed in mid-1970s. The air handling unit casing are in poor condition. Many of them show signs of collapse through structural failure or excessive pressurization. The

Mechanical Room - Interior

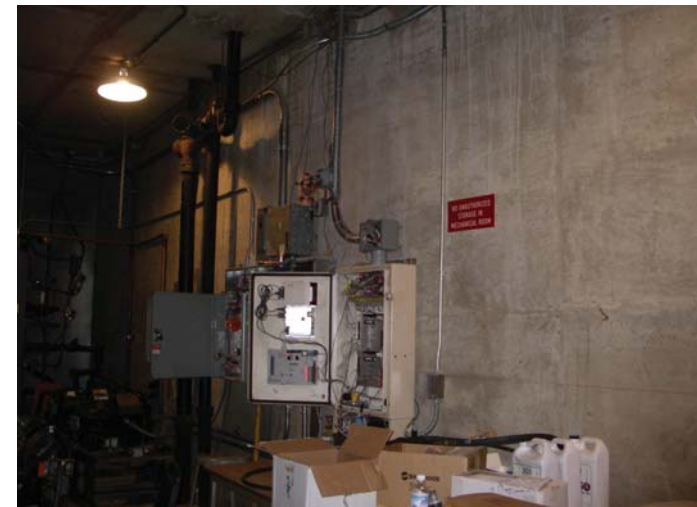
Two switchboards supply power to the existing school. Switchboard 1 is 3000A, 208/120V, three-phase. Switchboard 2 is 4000A, 480/277V, three-phase. There is an emergency back-up generator that seems to have been recently installed and in good condition. There are circuit breaker type electrical panels inside mechanical/electrical rooms throughout the school. Some of the panels appear to be old and overloaded.

Electrical Panels

It is recommended to update the electrical system to comply with current building and electrical codes since most of the equipment is from the original construction of the building. The generator can be salvaged and reused but it is recommended that it be tested to the NFPA 110 standards. The fire alarm system must be upgraded and applied throughout the building. The conduits, power receptacles and telecommunication junction boxes should be replaced and installed inside the walls. The lighting should be replaced and upgraded to comply with the energy code. While the electrical systems will require far less ongoing maintenance, the sub-standard (by today's standards) lighting levels and efficiency of the lighting and power systems represent a significant ongoing cost and impediment to the effectiveness of the facility for its intended use.
