*Arlington Career Center
Feasibility Study*

THE EXISTING FACILITY

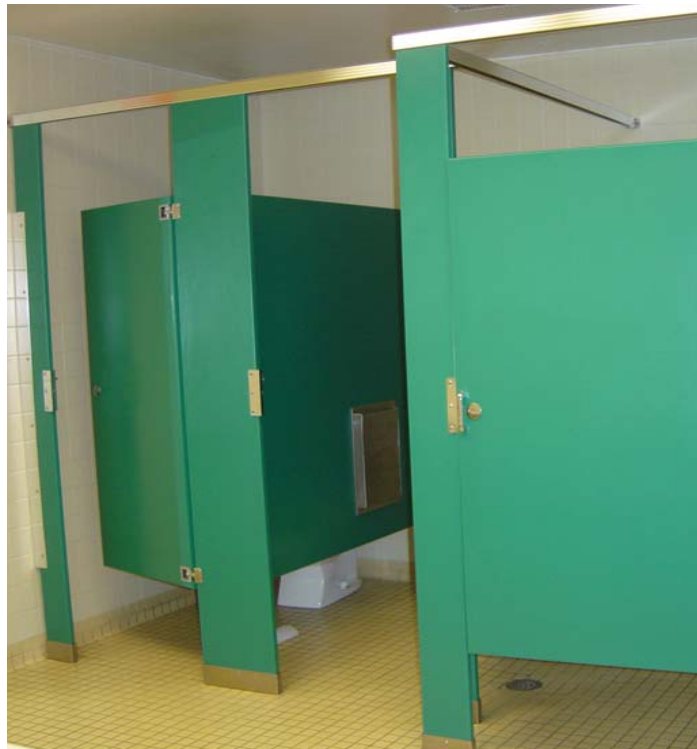
The toilet rooms in the Career Center are very basic and appear adequate for the current population. Minor adaptations have been implemented to provide handicapped accessibility, primarily at water closets. Lever handles, fixture heights, and accessory heights (mirrors) generally have not been addressed to meet ADA guidelines. The quantity of fixtures and sizes of the toilet rooms are inadequate by modern standards and code requirements, but this is typical for a building of this age. In general, the toilet facilities are meeting the daily needs and demand, except when special functions are held with above average attendance.

The toilet rooms are well maintained and serviceable. The floors are typically ceramic tile and the walls are either painted masonry or painted dry-wall.

Typical Toilet Room

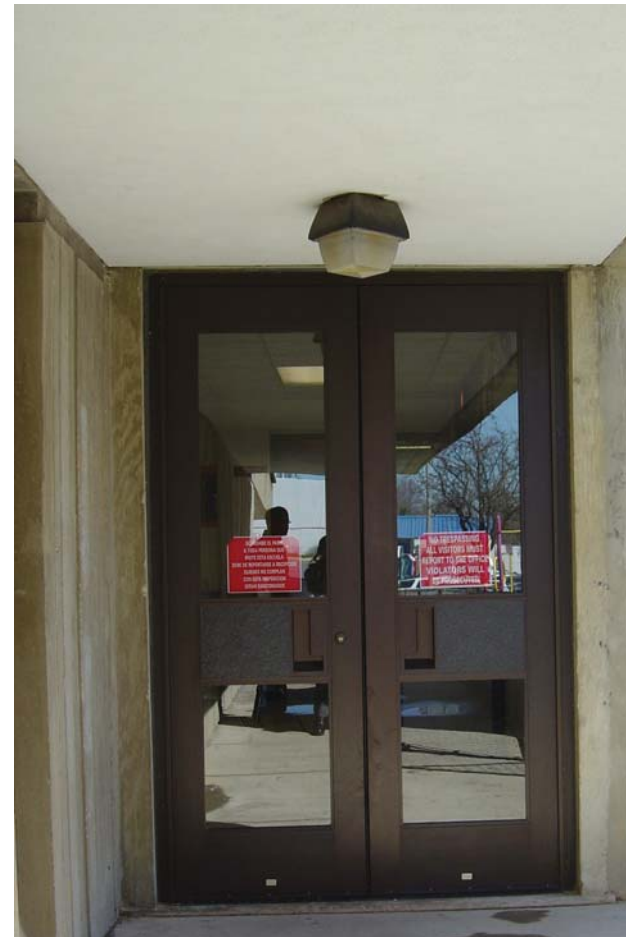
Both doors and door hardware are functional and adequate. There is a mixture of hollow metal and wood doors. At rated assembly locations, door hardware, including closers, generally bear the appropriate rating certifications and function correctly. There are a number of locations where both doors and door hardware need repair or adjustment, as is the case with any facility of this type. Ongoing maintenance and periodic monitoring of deficiencies should address these deficiencies and allow both to function adequately into the future.

Typical Exterior Door

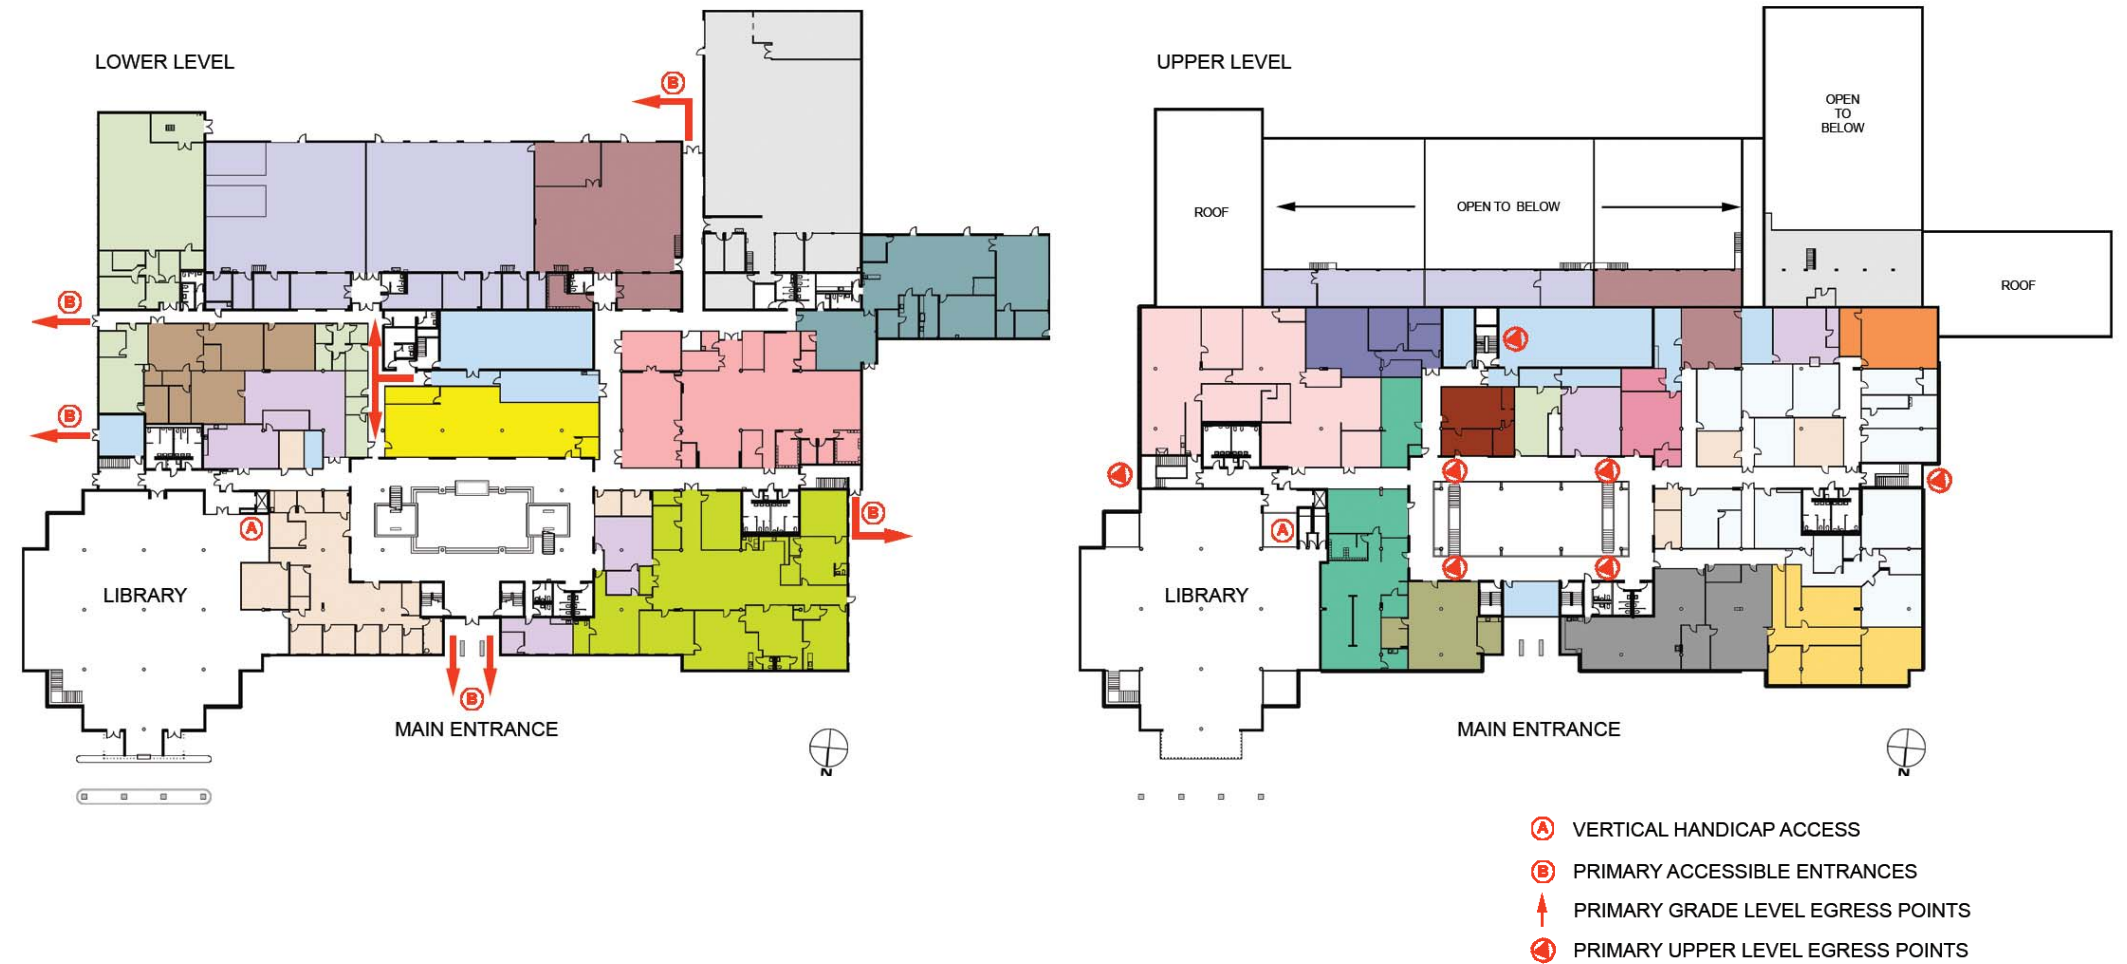
Access and Egress Plan

The building has a number of grade level egress routes out of the facility and fire-rated stairwells exiting directly to grade. The egress routes, door widths, and stair railings do not comply with current code requirements, which are more stringent than the requirements at the time the facility was designed and constructed. Since the building has not been renovated or changed use, the existing egress pathways and requirements are adequate for the facility and do not have to be brought up to current standards, until a substantial renovation is undertaken.

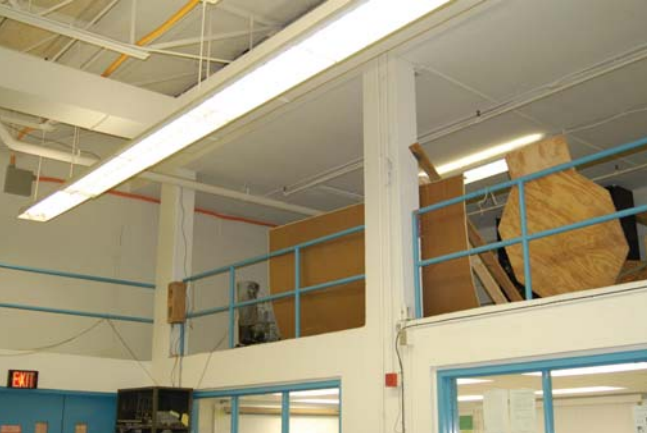
Photograph 3

Where the one-story portion of the building abuts the two-story portion, there are mezzanines, accessible only through the shop classrooms (Photograph 3 and 8). The roof above these mezzanines is lower than the two adjacent roof planes and has parapet walls around its perimeter, forming a yard used for the placement of roof top mechanical units (Photograph 4).

The mezzanine floor and roof immediately above the mezzanine consist of cast in place, concrete, flat slab construction. These slabs are supported on cast in place concrete walls, with some concrete beam and column construction where there are openings in the bearing walls (Photograph 3 and 8).

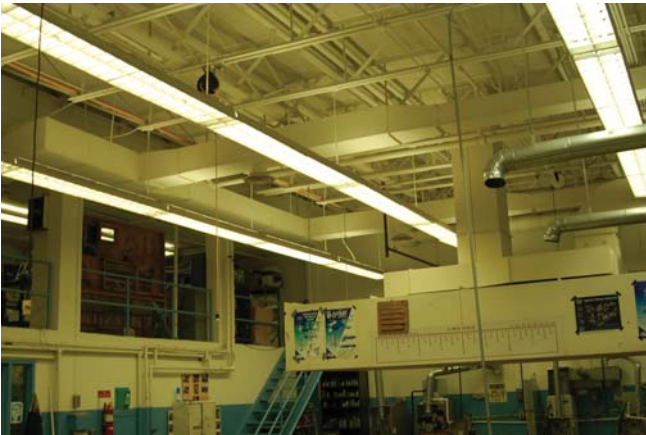
Photograph 8

At the one-story portion of the building, the roof structure consists of long-span, open-web, steel joists supporting a 3 inch composition roof slab (Photograph 8). The joists are supported on 10 inch, load bearing, cast in place, concrete walls by means of a stiffened angle ledger bolted to the vertical concrete surface (Photograph 9 and 10).

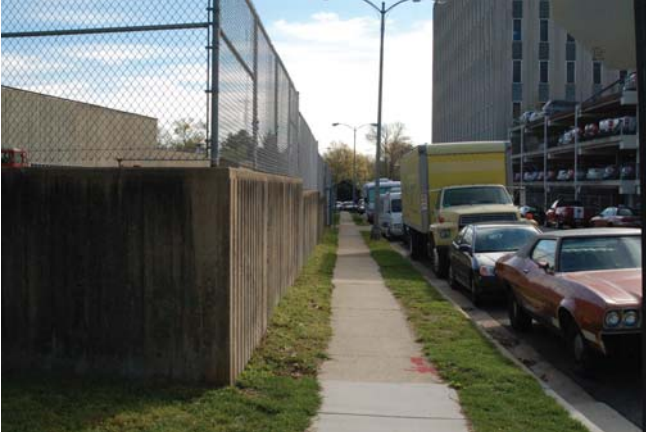
Photograph 12

Along portions of the south and west edges of the property, there are cast in place concrete site walls that retain earth for a significant portion of their length (Photograph 12).

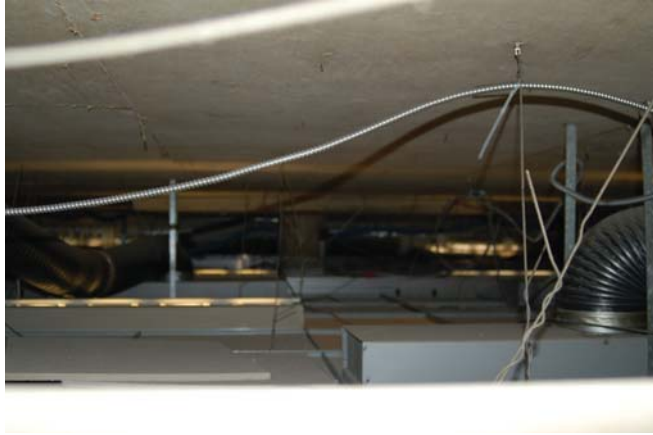
Photograph 5

At the two-level portion, the typical bay of the floor and roof structure consist of a reinforced, two-way, 9 inch thick, flat concrete slabs with 4½ inch drop panels at the columns (Photograph 5). Columns are typically 18 inch round concrete columns. The building has two expansion joints through the shorter dimension of the elevated floor and roof (Photograph 6 and 7). The joints isolate the building slabs at the one-quarter and the three-quarter points of the building footprint.

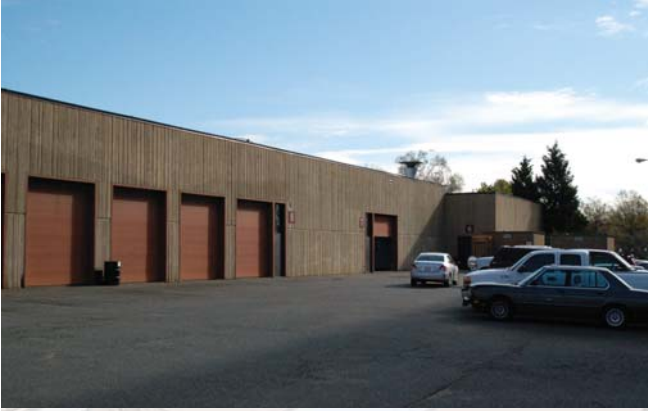
Photograph 1

The existing building is a one and two-level, cast in place concrete structure with two distinct parts. The two-level portion of the building houses mostly classroom and administrative areas (Photograph 1), while the one level portion in the rear houses the high bay shop classrooms for building construction, auto trades, and animal science instruction (Photograph 2). In the central region of the building there is an atrium, or two-story space, that occupies three building bays (photograph 11).

The ground level floor of the building consists of a 6 inch thick concrete grade slab. The original structural drawings identify that the building is founded on conventional spread footings. Lateral stability of the building appears to be provided by some frame action of the concrete columns, but mostly by the shear action of the cast in place concrete walls (Photograph 1 and 2).

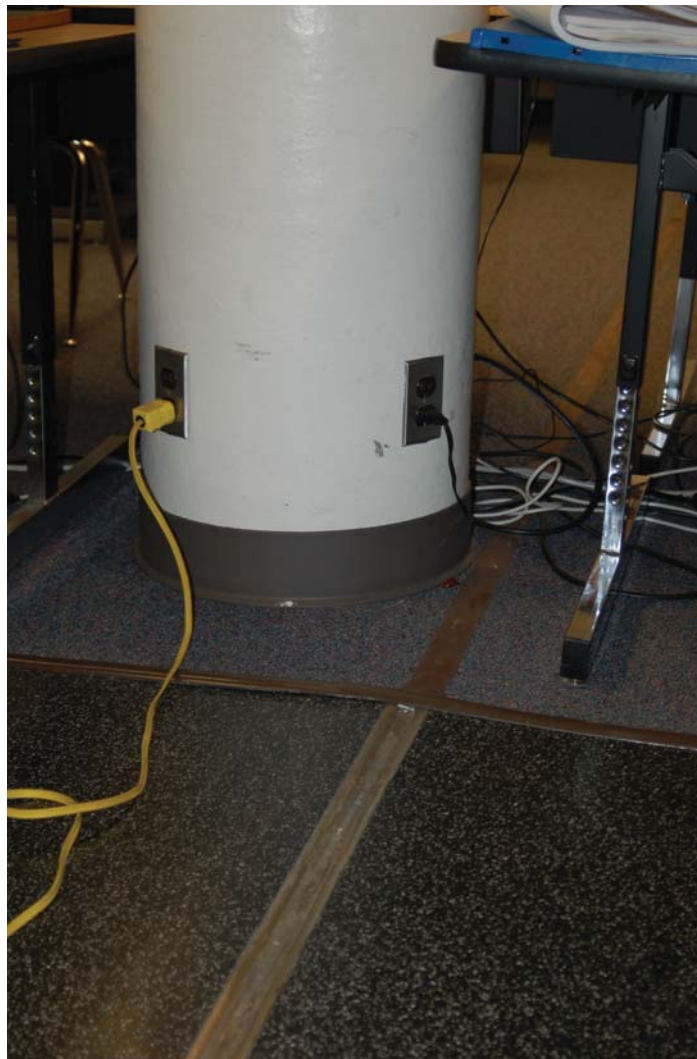
Photograph 11

Immediately around the atrium, the floors are framed with flat concrete slabs supported on cast in place concrete beams. These beams project past the slab edge extending to two-story columns that are situated within the two-story atrium space (Photograph 11). There are stairs at each end of the atrium that consist of cast in place concrete construction.

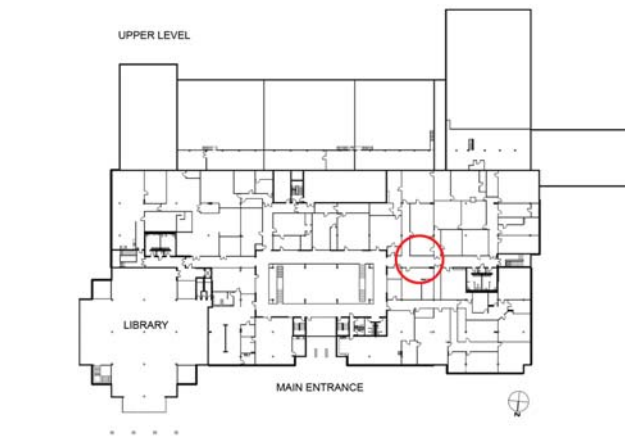
Photograph P10

At the interior of the building, one significant issue was observed to occur at two specific locations. Significant deflection of the elevated floor slabs was observed at each side of the column lines along the two expansion joints (Photograph P10 and P11). Based on our discussion with some of the staff in the building at the time of the survey, this condition has been evident for a long time.

In our opinion, the excessive deflection appears to be a combination of elastic deflection due to the slab thickness given the pinned condition; and plastic deformation, or creep, due to under-reinforcement of the slab. This condition will require a more in-depth study by a qualified structural engineer, in order to determine actual live load capacity, and to establish if the available load capacity is sufficient to satisfy code required minimums.

If as a result of this in-depth study, it is determined that strengthening of the structure in the four bays affected by this condition, it is likely that the slab would have to be strengthened by the addition of steel beams and columns underneath the slab. Additional columns would be added to shorten the slab spans and beams would be added to stiffen and strengthen the existing slab. The upper surface could then be made level with a self-leveling cementitious topping material.

If found to be deficient, add a single line steel columns and beams at mid-span of each of the four bays (each side of the expansion joints). Columns will extend two-stories to the underside of the roof and will bear on new concrete spread footings constructed beneath the grade slab.

Portions of the grade slab must be removed and replaced in order to install these footings. We estimate W12 steel columns on the column on the same spacing as the 18" concrete columns, heavy W18 steel beams, and 8 foot square by 20 inch thick concrete footings.

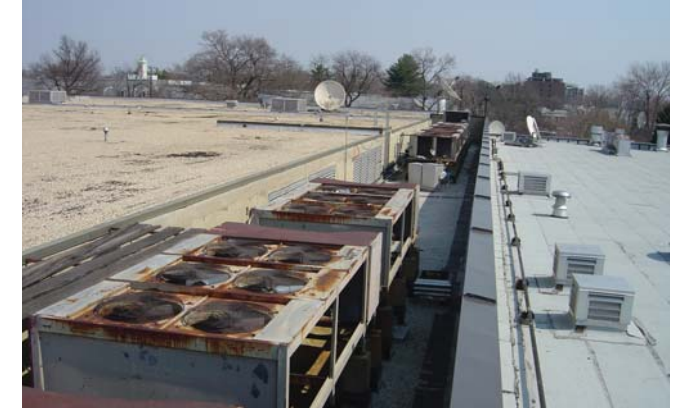
Roof Top Mechanical Equipment

access doors have visible air gaps when closed. The roof mounted condensing units are in poor condition. The existing cooling system appears to be in poor condition, well beyond its intended service life, not energy efficient, and incapable of providing appropriate levels of zone temperature control to meet present educational requirements. The outside air levels are also well below the levels expected to meet present building codes.

During the visit, none of the air handling units serving the first and second floors were operating and consequently no ventilation air was being introduced into the building. Additionally, many of the compressors were in the process of being replaced. The condensing units on the roof are in poor condition.

A completely new heating, ventilation, and air-conditioning with appropriate building and zone control is required. The new system will provide appropriate ventilation and filtration for the health of the building occupants, and appropriate energy conservation features for the benefit of the County in accordance with current energy code standards. In general, the system has exceeded its expected useful life and will need more and more maintenance. Despite ongoing maintenance, it will continue to perform below expected minimum standards.

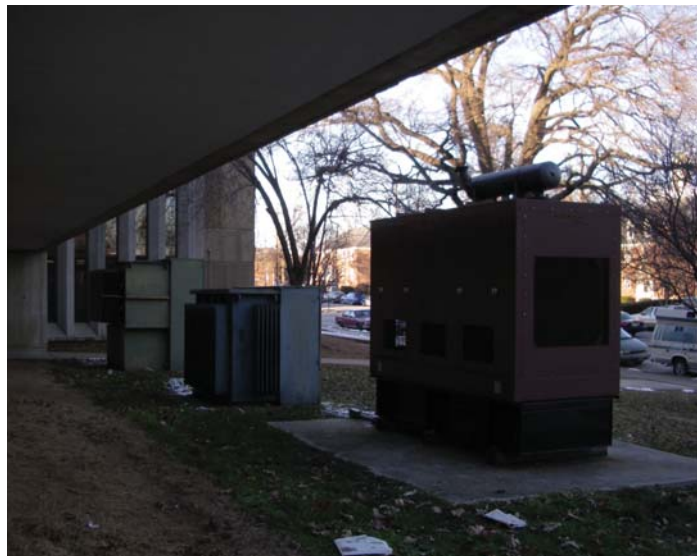
Generator

Two switchboards supply power to the existing school. Switchboard 1 is 3000A, 208/120V, three-phase. Switchboard 2 is 4000A, 480/277V, three-phase. There is an emergency back-up generator that seems to have been recently installed and in good condition. There are circuit breaker type electrical panels inside mechanical/electrical rooms throughout the school. Some of the panels appear to be old and overloaded.
